SUMMARY
801 Royal Ave, Midwest City, OK
73130
Jack Lander
August 16, 2023

John May Lic #1873
Internachi Certified Home Inspector
Sooner Home Inspections
405-792-0407
soonerhomeinspections@gmail.com

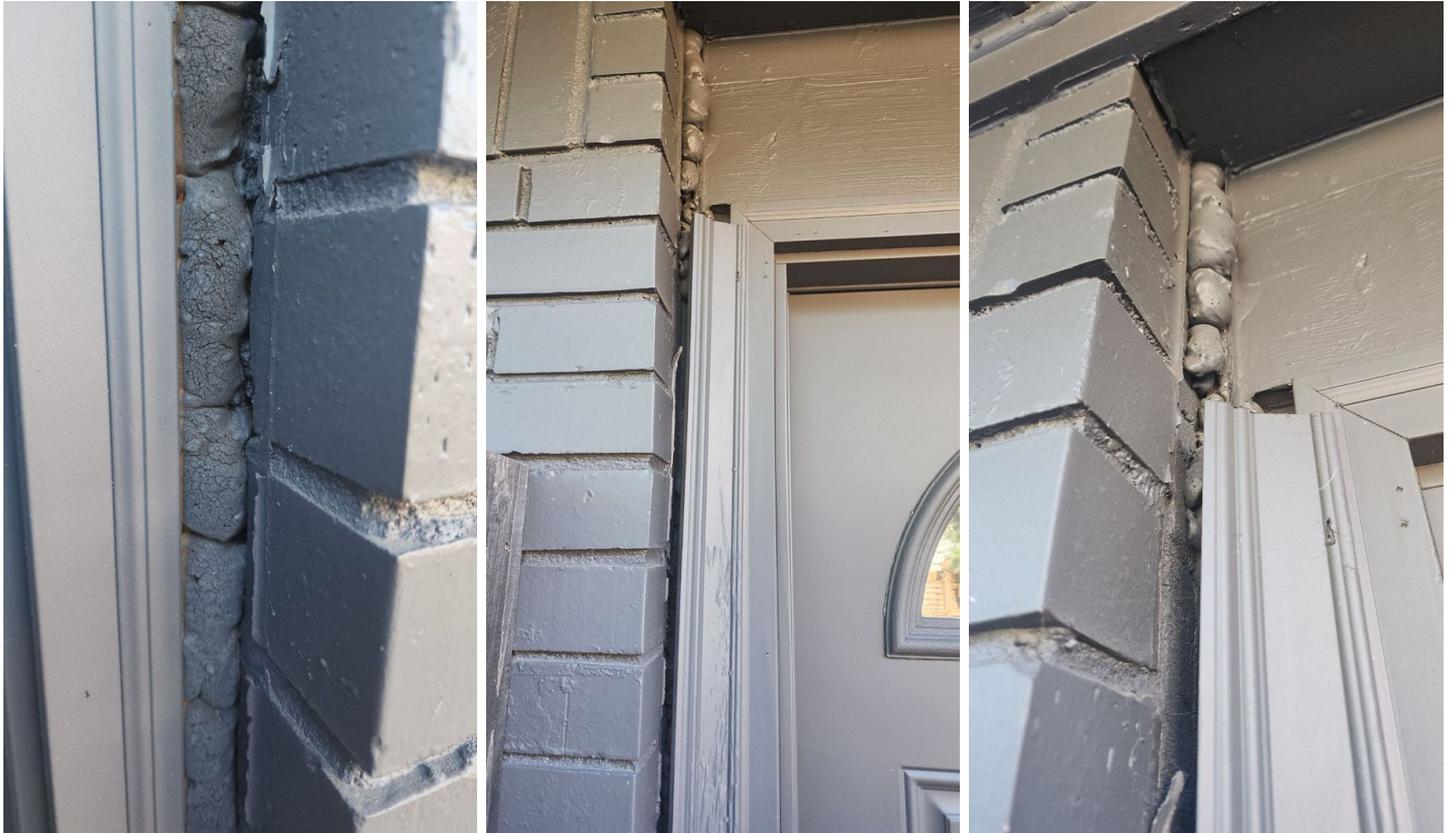
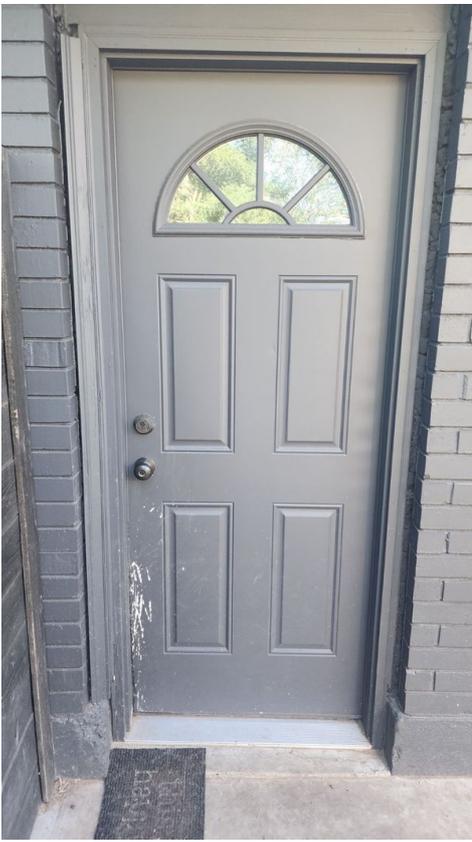
2.2.1 Exterior Doors

LARGE GAPS - BACK DOOR

Large gaps are present around the back door. These gaps have been filled with expanding foam which will deteriorate when exposed. We recommend this door be installed correctly and be properly sealed.

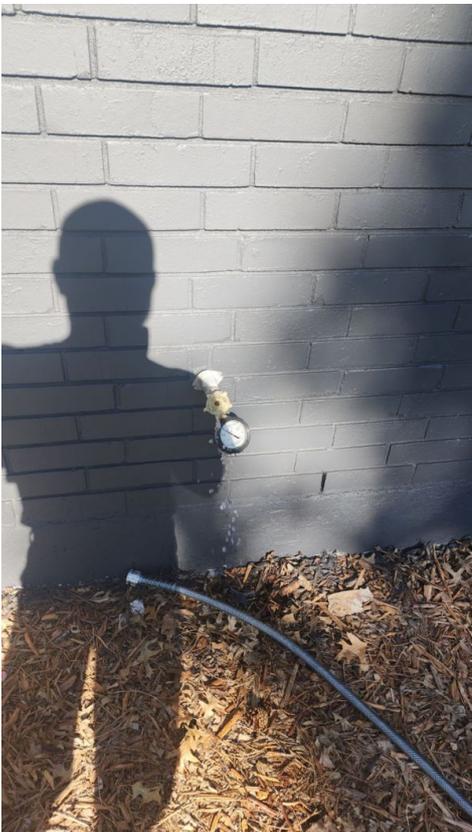
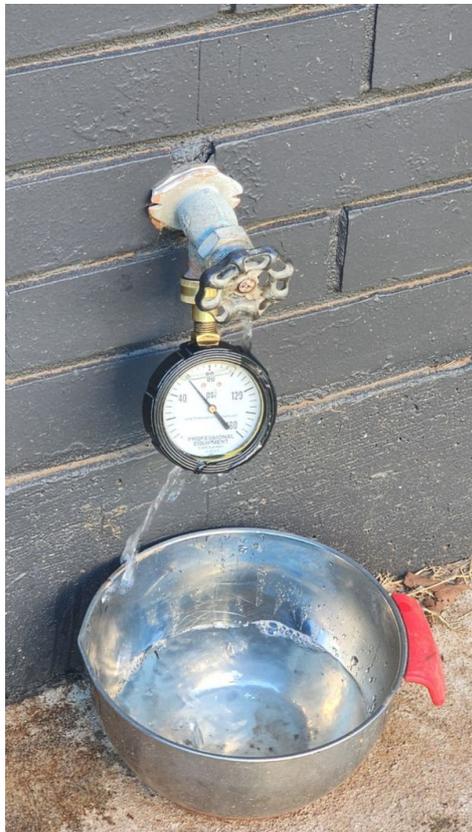
2.6.1 Exterior Faucets

HOSE BIB LEAK

FRONT, BACK

There is a leak at the hose bib when used under pressure, recommend this be repaired.

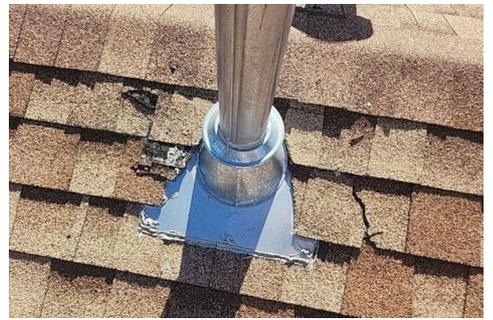
3.1.1 Coverings

DAMAGED SHINGLE(S)

Roof coverings showed damage. Consult a qualified roofing professional for evaluation, repair, and to verify insurability.

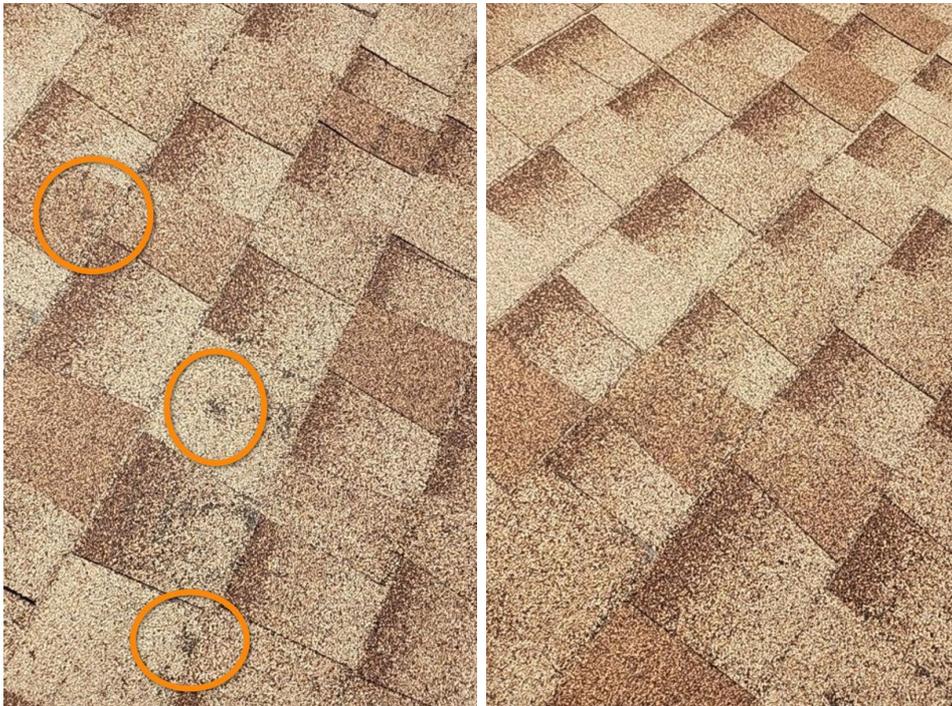
3.1.2 Coverings

FUNCTIONAL HAIL DAMAGE

At the time of the inspection, the asphalt composition shingle roof had damage visible that appeared to be the result of hail strikes. Implications: 1. Reduces the ability of the roof to shed water; &/or 2. Significantly shorten the shingle's long term service life. Consult a roofing professional for evaluation, repair, and to verify insurability.

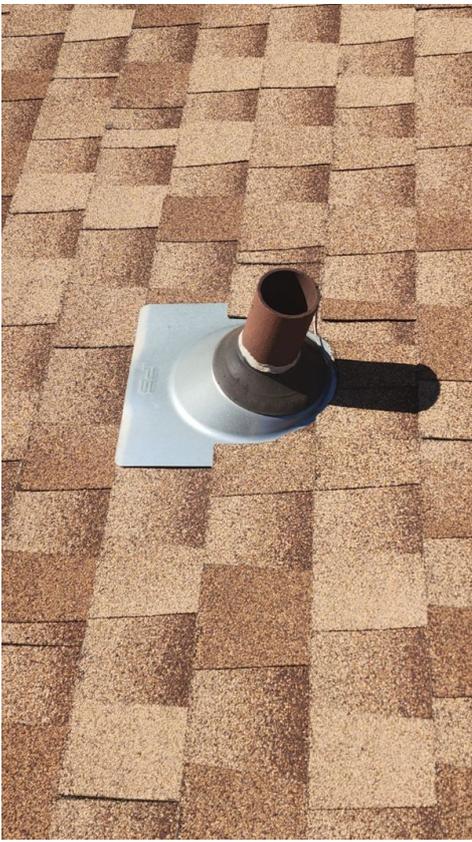
3.4.1 Flashings

FLASHING NOT SECURED

The flashing is not secured. Recommend this is secured to prevent moisture intrusion.

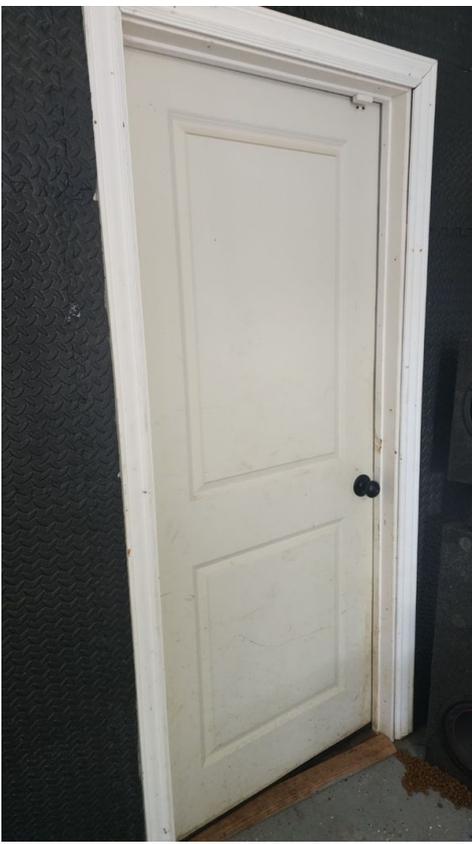
5.7.1 Occupant Door (From garage to inside of home)

DOOR DOES NOT MEET SEPARATION REQUIREMENTS

Door separating garage and home does not meet safety standards. Doors in firewalls must be at least 1 3/8-inch thick, metal/steel, or a 20-minute fire-rated door.

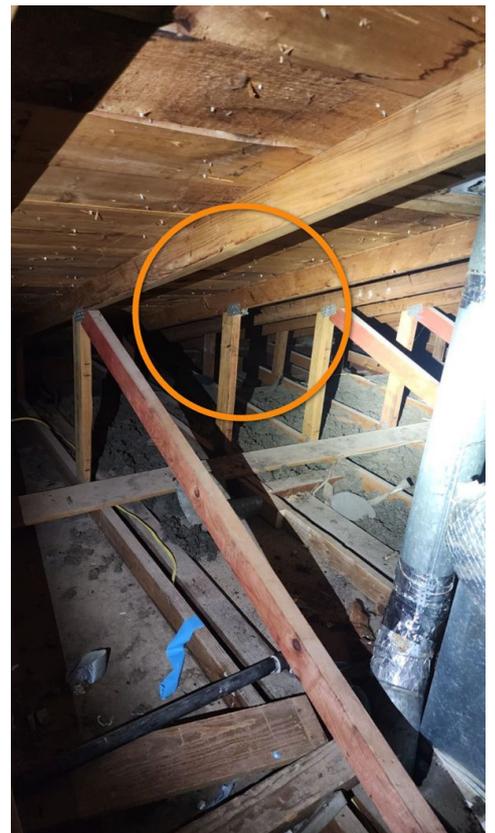
6.1.1 Roof Structure & Attic

MODIFIED TRUSS

One truss has been modified. The roof truss system is engineered and should not be modified. We recommend this be evaluated by a qualified contractor.

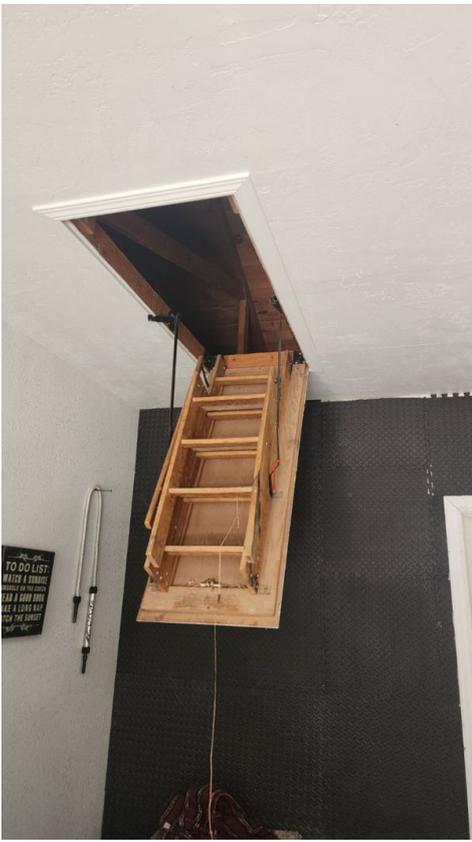
6.2.1 Pull Down Attic Ladder

DAMAGED - UNSAFE

The attic ladder is damaged and should not be used until it is repaired or replaced.

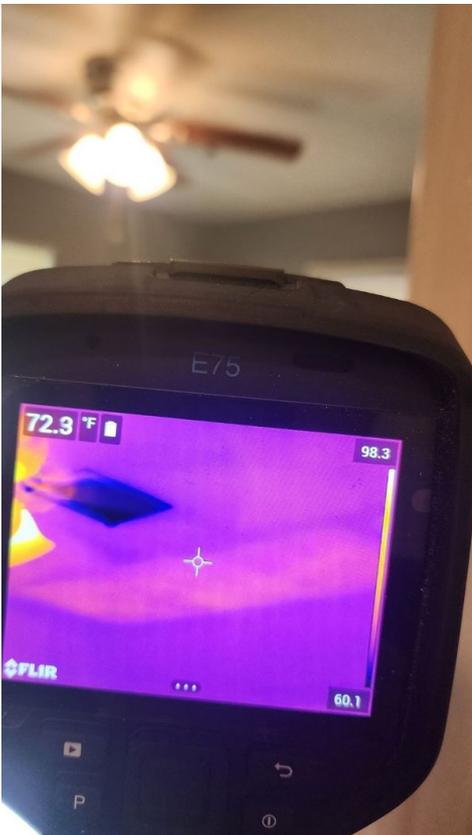
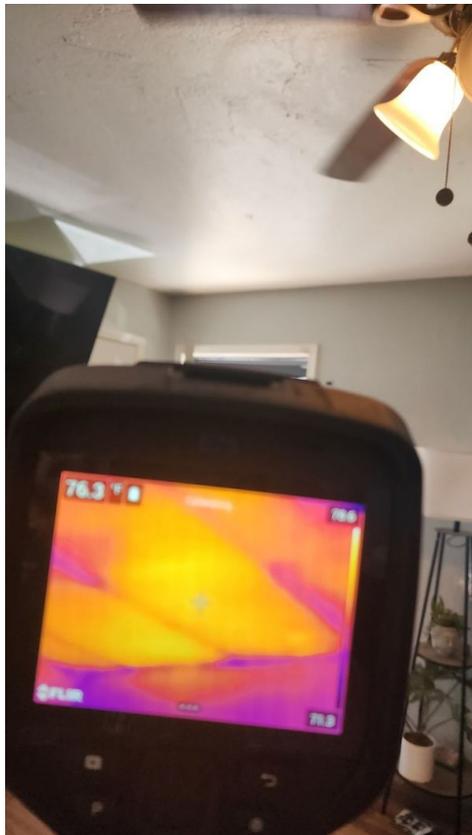
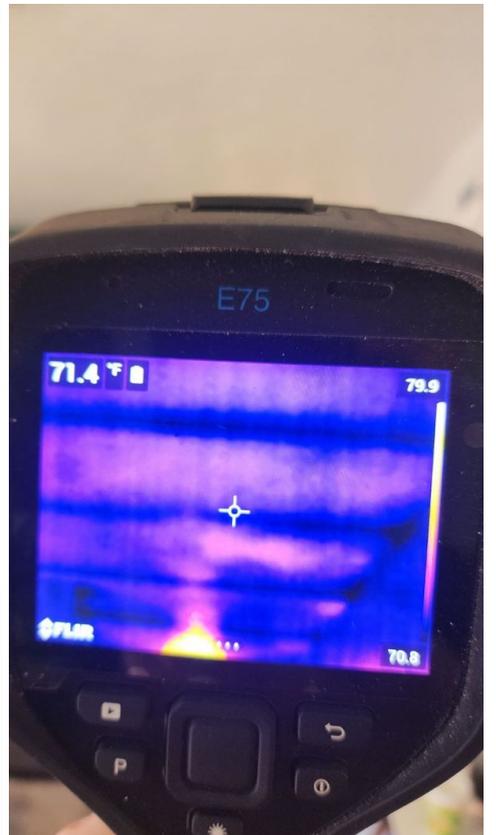
6.3.1 Attic Insulation

GAPS OR VOIDS

Gaps are present in the ceiling insulation. Recommend adding additional insulation for improved thermal efficiency.

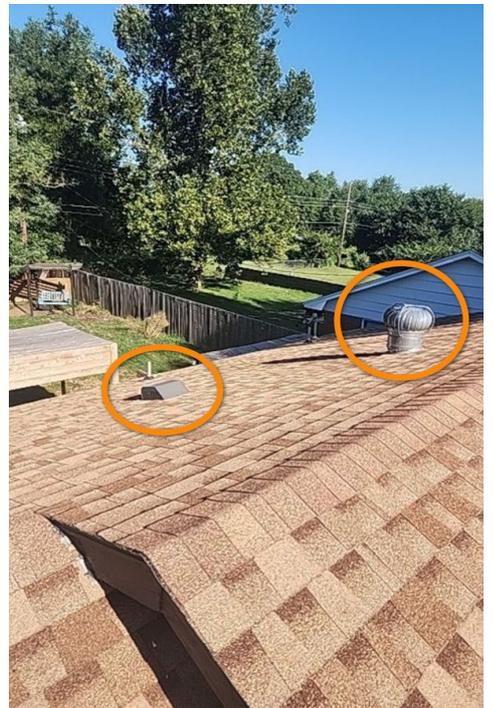
6.4.1 Attic Ventilation

MIXED VENTILATION

We do not recommend mixing two types of exhaust vents on the same roof when its a common attic because it could result in short-circuiting the attic ventilation system in which one of the two exhaust vents becomes intake resulting in possible weather infiltration and less than optimal attic ventilation for the entire underside of the roof deck.

There are generally four groups of exhaust vents: ridge vents, wind turbines, roof louvers/gable louvers, and power vents. Each group uses the wind differently. If any of these different groups of exhaust vents are mixed there will potentially be a short-circuiting situation.

Short-circuiting the ventilation system will result in areas of the attic being bypassed (skipped). The system will still be venting, but it will not be performing optimally. Furthermore, weather infiltration is a very real possibility

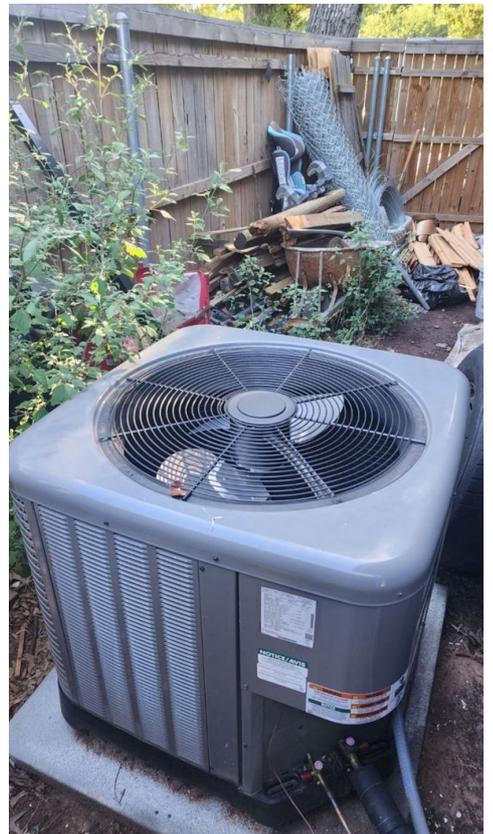
8.1.3 Equipment

VEGETATION TOO CLOSE

Vegetation was too close to the compressor, which can limit heat dissipation and limit effectiveness. Recommend cutting back vegetation to avoid overheating compressor.

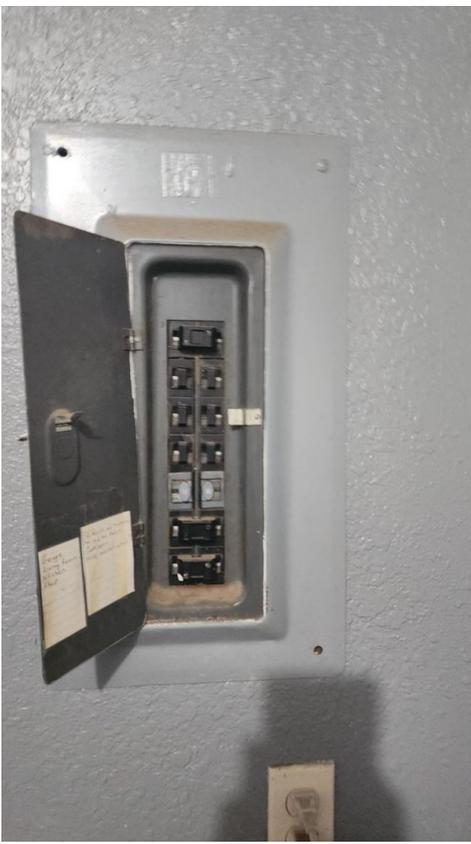
9.2.1 Main Panel Service & Grounding, Main Overcurrent Device

PANEL SCREWS MISSING

One or more panel screw(s) are missing, for safety we recommend this be replaced.

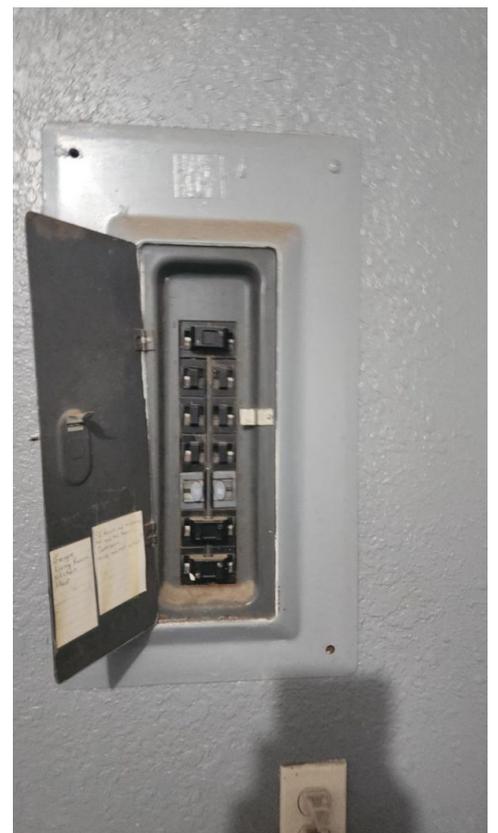
9.2.2 Main Panel Service & Grounding, Main Overcurrent Device

PUSHMATIC PANEL

This panel is an older type that is no longer manufactured. Due to age we recommend this is evaluated by a qualified contractor and would be worth considering updating to a newer panel.

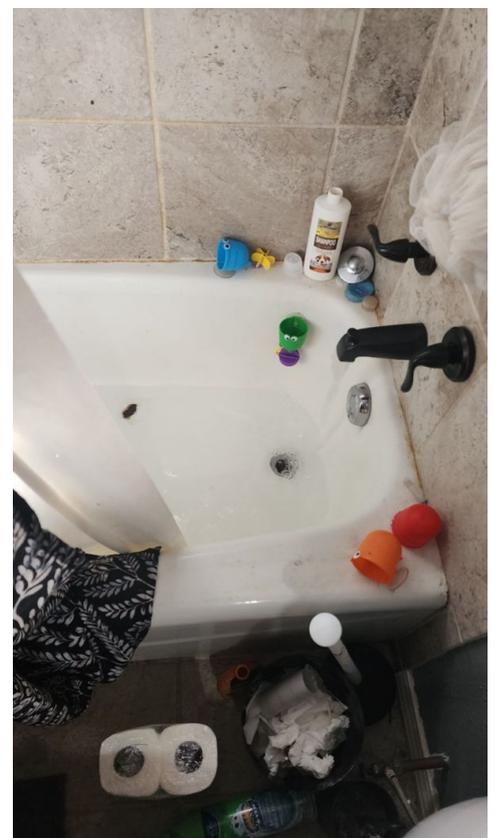
10.3.1 Sewage & Drain, Waste, & Vent (DWV) Systems

SLOW DRAIN

BATHROOM

Slow/poor drainage observed. Recommend these traps are cleaned and tested for correct function.

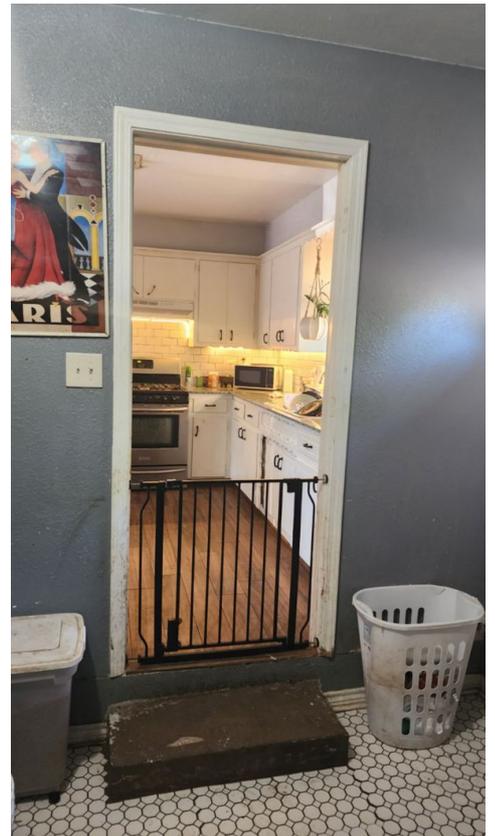
11.2.1 Doors

DOOR MISSING

A door is missing, recommend this is replaced.

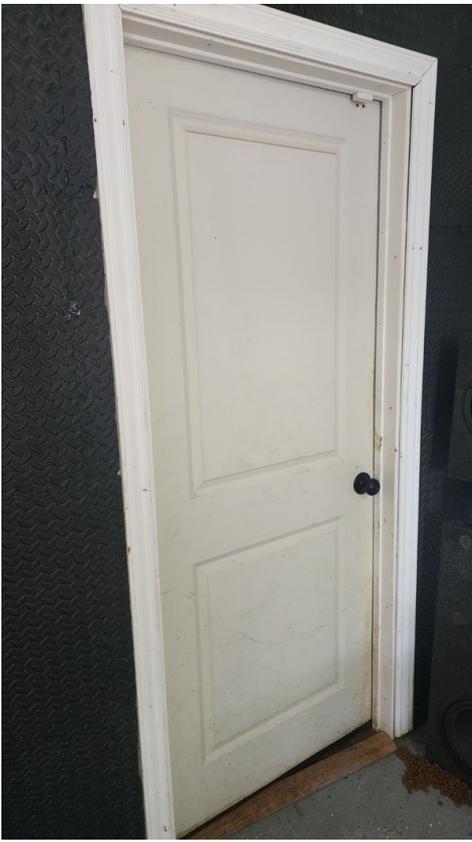
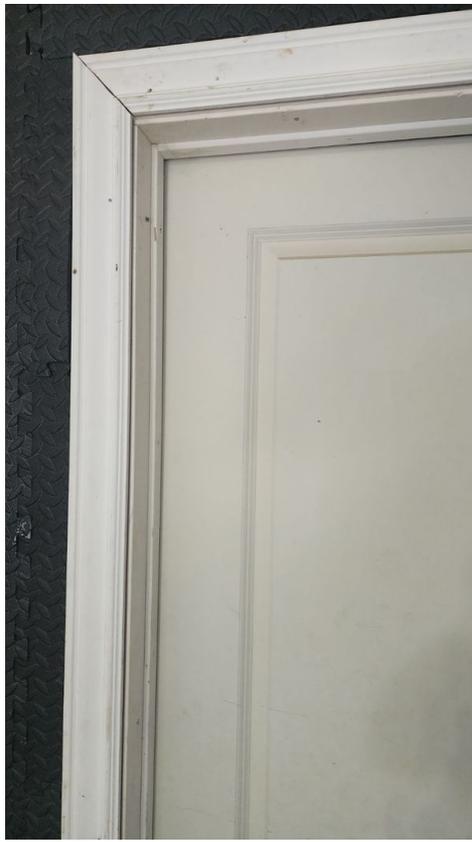
11.2.2 Doors

HINGES LOOSE

GARAGE

Loose hinges can cause door to stick or eventually fall out of place.

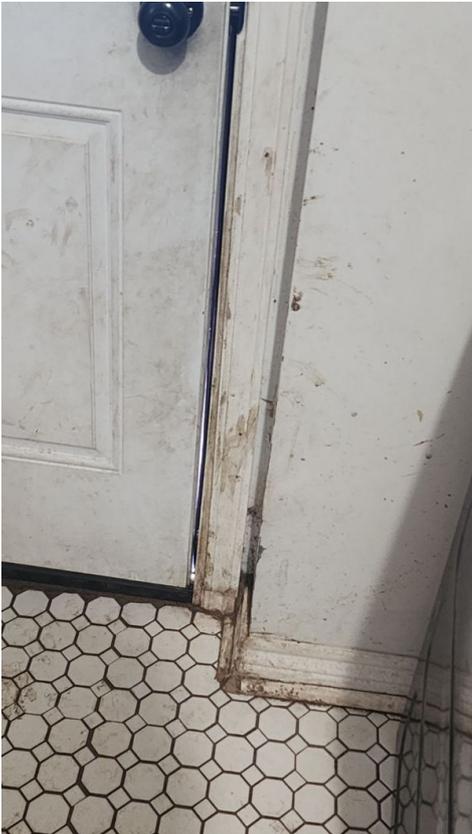
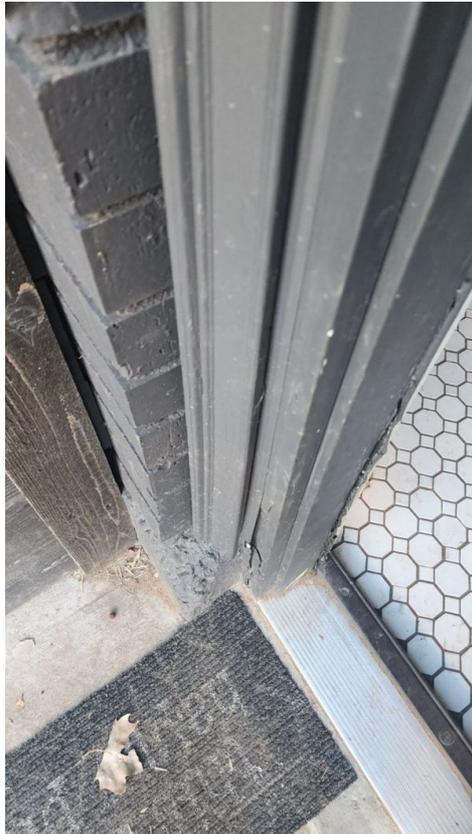
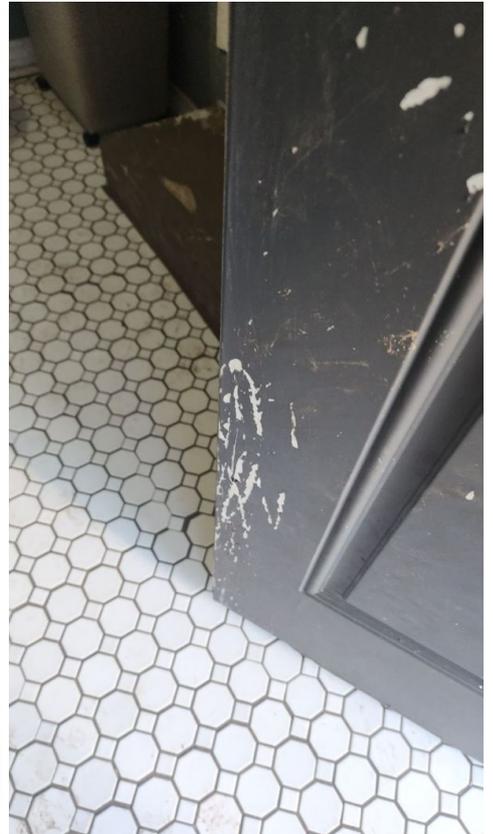
11.2.3 Doors

DOOR- DOG SCRATCHES

BACK DOOR

Damage to the door is the result of a dog scratching to get in/out. Weather stripping and trim are damaged, these should be repaired.

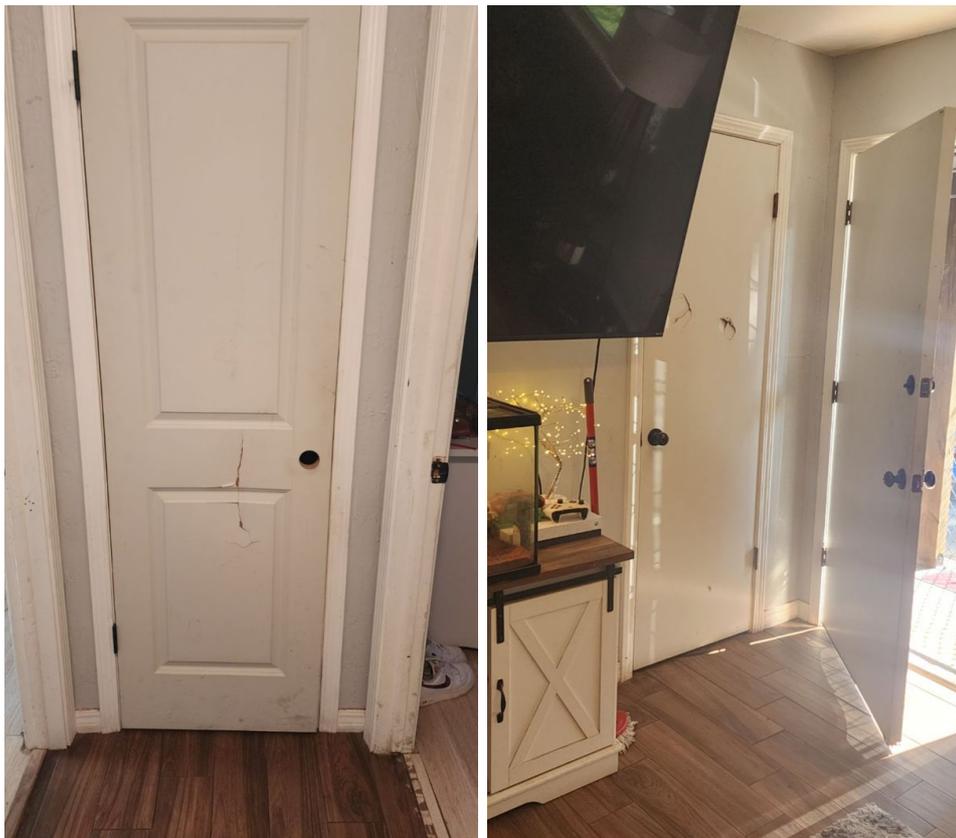
11.2.4 Doors

MODERATE DAMAGE/DETERIORATION

VARIOUS

Doors exhibited general moderate damage or deterioration.

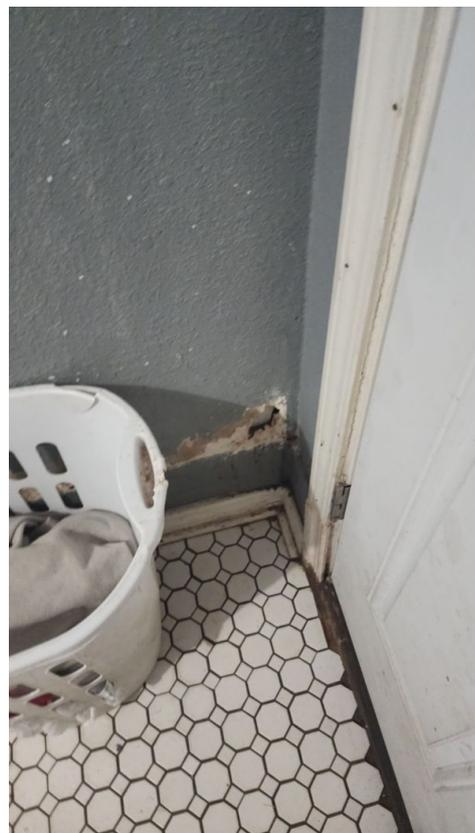
11.5.1 Walls

WALL DAMAGE - DOGS

LAUNDRY ROOM

Damage done to a wall, likely due to dogs. We recommend this is repaired.

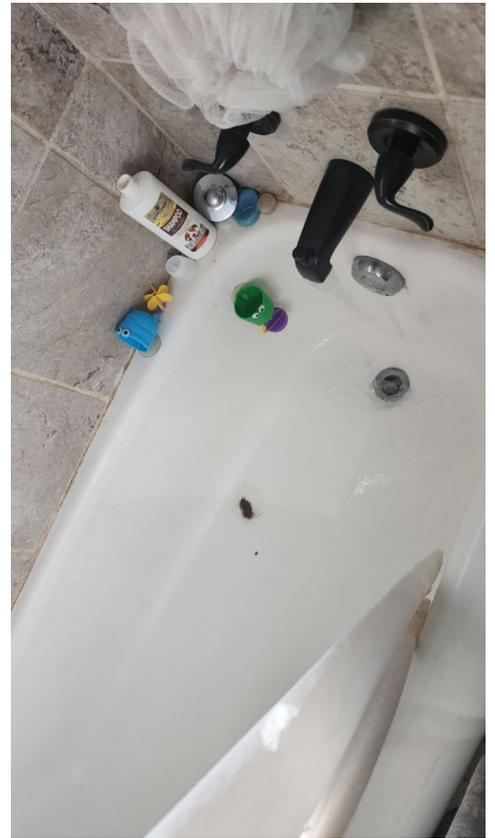
11.9.1 Tiled Areas- Kitchen, Bath & Laundry

BATH - CHIP

Minor chipping noted at bath tub. We recommend this is repaired.

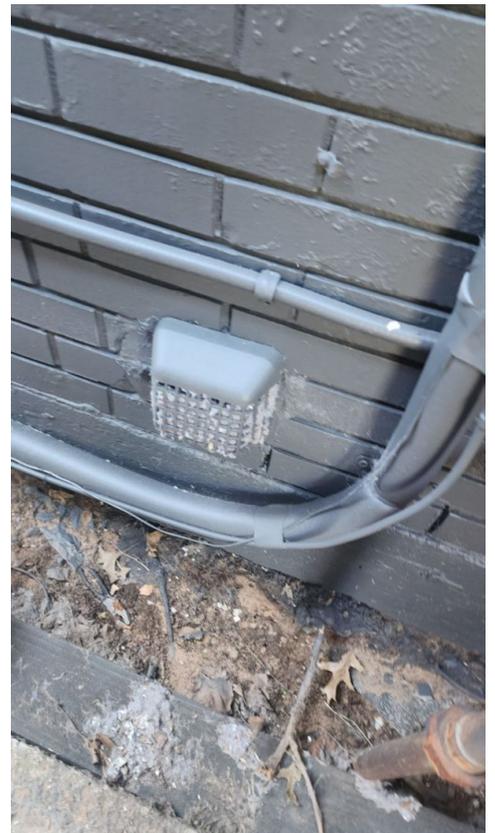
11.10.2 Laundry Facilities

DRYER VENT OBSTRUCTED

The dryer vent is obstructed, we recommend this be cleaned for improved dryer performance and safety.

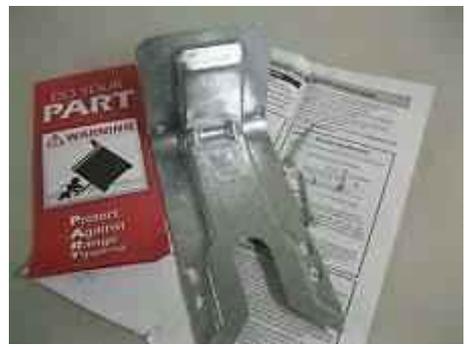
12.1.1 Range

NO ANTI-TILT DEVICE

There is no anti-tilt device installed at the range. These are used to secure the range to the wall or floor to prevent tipping over and causing personal injury.

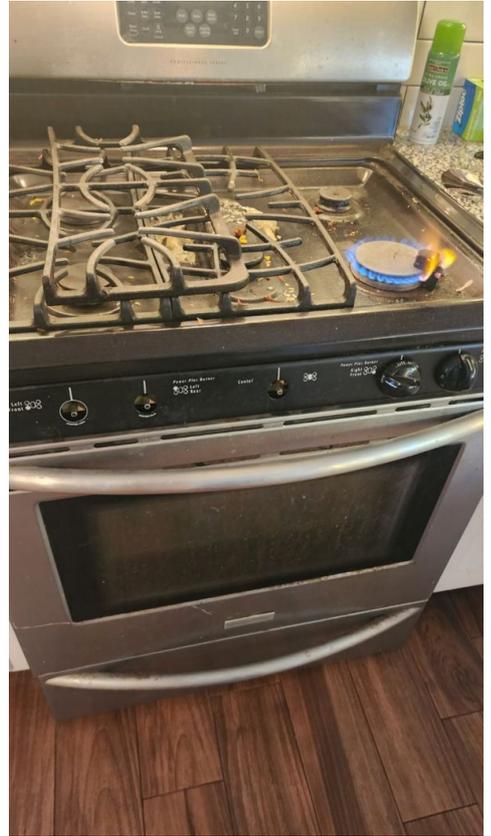
12.1.2 Range

UNTESTED MISSING CONTROL KNOBS

The stove top is untested due to missing control knobs.
